Milestone Inspection – Phase 1

Five Towns of St. Petersburg No. 304 Condominium Association

5521 80th St. N. St. Petersburg, FL 33709

March 11, 2024

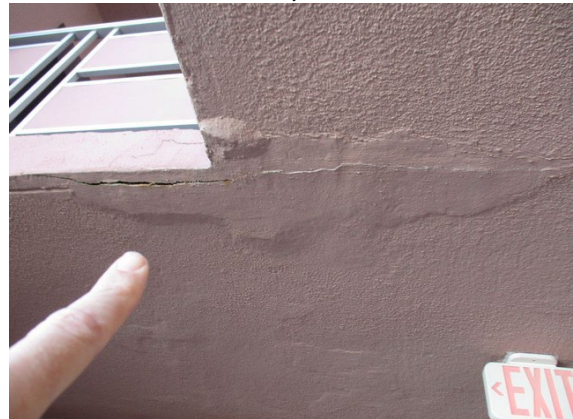
- Building 1, Level 1
 - No concerns of note
- Building 1, Level 2
 - No concerns of note
- Building 1, Level 3
 - No concerns of note
- Building 1, Level 3 near unit #316 & #315
 - Stucco bulging at expansion joint which does not appear to be structural. Area needs to be addressed at next exterior paint.
- Building 1, Level 4
 - No concerns of note
- Building 1, Level 5
 - No concerns of note

38 3rd Floor Walkway Ceiling Stucco Bulging At Expansion Joint

For the Exterior Walls/Breezeways, we do not recommend that the breezeways and walls have a Phase 2 destructive testing performed. We recommend that the painting/waterproofing schedule is strictly adhered to. As part of a yearly inspection, we recommend that any surficial cracks developing are sealed with elastomeric sealer between formal painting cycles.

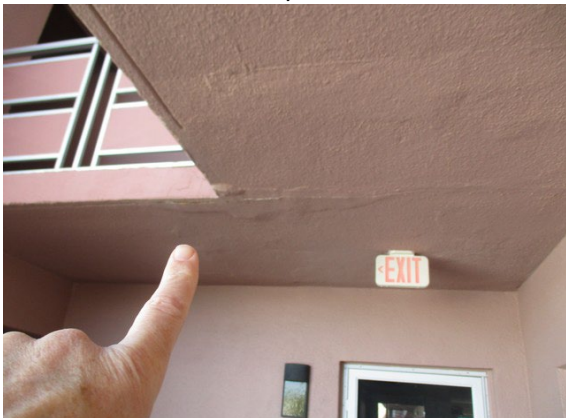
39 3rd Floor Walkway Ceiling Stucco Bulging At Expansion Joint

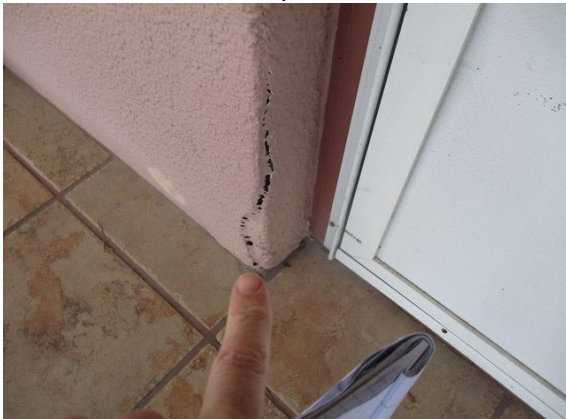
- Building 1, near unit #108
 - Vertical crack noted at the bottom of door frame. Crack should be vee-grooved with a backer rod and elastomerically sealed at next exterior paint.

45 1st Floor Vertical Crack @ Unit #108 Doorway

For the foundation, we do not recommend that the foundation have a Phase 2 destructive testing performed. When the breezeways/walkways are sealed, we recommend that any slab-on-grade cracks are repaired with epoxy. Differential settlement may require high-strength concrete injection as part of a preventative maintenance plan. We further recommend removing any large shrubs or trees within 5 feet of the structure.

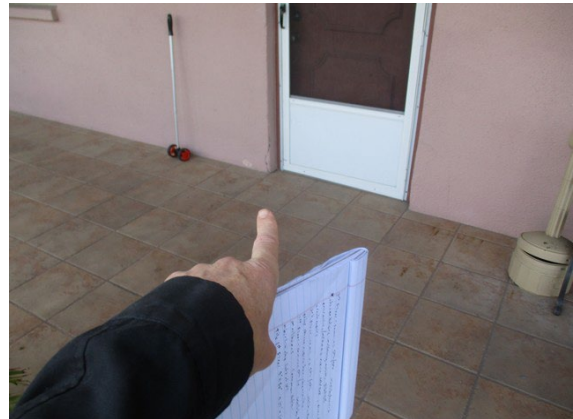
46 1st Floor Vertical Crack @ Unit #108 Doorway

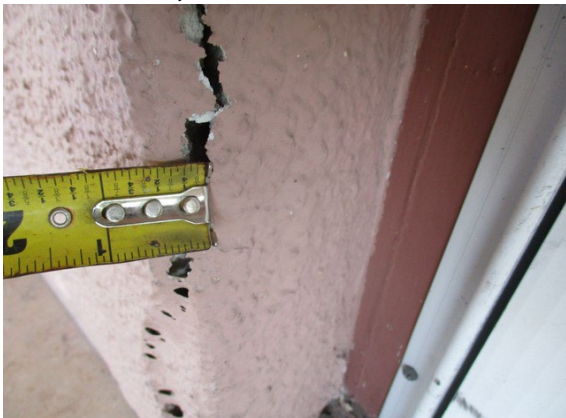
47 1st Floor Vertical Crack @ Unit #108 Doorway
